Award Number: DAMD17-00-C-0031

TITLE: Modeling for Military Operational Medicine Scientific and  
Technical Objectives

REPORT DATE: September 2004

TYPE OF REPORT: Annual

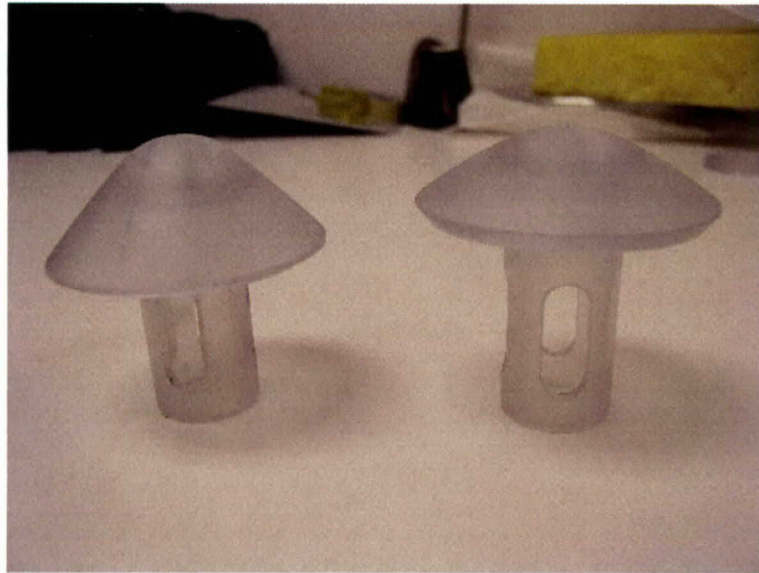
**Impactor clay tests** were conducted using a soft armor impactor and a hard armor impactor, as shown in Figure 2 below. These impactors have different diameter, shape and mass and simulate the behind soft and hard body armor impacts, respectively, at given speeds. Before each test, the clay was heated, using two heating pads and a reflective shell to contain the heat within the clay. The average temperature, taken along four equally spaced depths at nine equally spaced locations on the clay surface, was 93°F. During the tests, the impactors were driven by a piston that was launched by high pressure helium gas. The pressures in the tests varied from 100-800psi. These impactors free-flew after the launching rod was pushed to the end of its length, culminating in the collision with the clay block. The results from the clay tests performed using the impactors are given in Table 1.

Figure 2. SBA Impactor (left) and HBA Impactor (right)

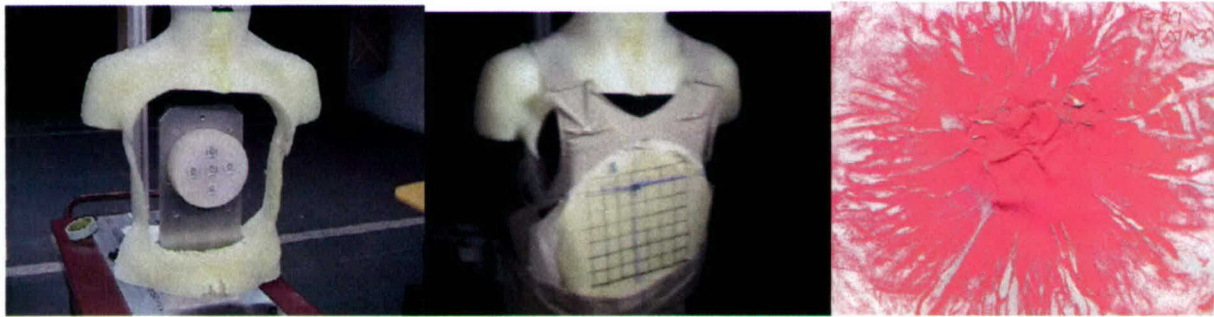
For live fire ATM tests, varying thicknesses of Dragonskin, half inch and one inch, were then placed on top of ATM to both protect the sensor units and to simulate the soft tissue covering the thorax. SBA of varying levels were placed over the thorax, with Fuji film placed between the Dragonskin surface and the SBA (Figures 4.2b). Accelerometers, FlexiForce sensors, chronographs, and a high speed camera were used to record loading measurements, bullet velocities, and wave propagation along the armor surface during each live fire test. The level of armors, bullet types and speeds are given in Table 4

Figure 5. Live fire testing (a) ATM testing setup; (b) ATM – Armor test setup; (d) Fuji film result for ATM live fire test

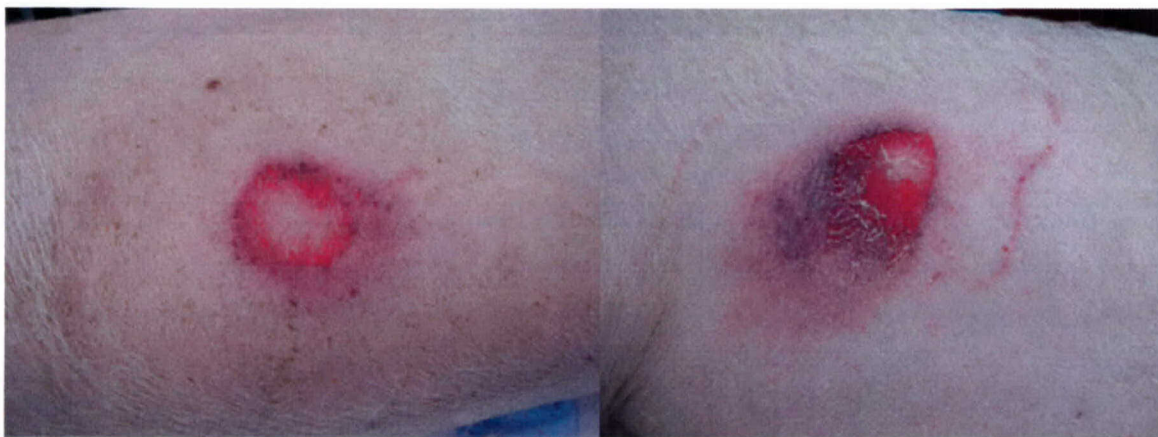
The injuries sustained by the subjects in the animal study compared well, and exhibited similar tendencies, when contrasted against the injury patterns in other experiments. The impacts from the animal study caused bruising and skin lesions to immediately form following the intervention. As time progressed, ecchymotic areas began forming in a similar manner to that observed in the NATO and the Magnan and Sarron studies (see Figure 13 below).

**Figure 13. Comparison of skin lesion formation and ecchymoses with NATO study**
